## RESIDENTIAL REPORT

Paradisiac Beach Club #356  
Richmond, St. Ann Parish JMCAN20

Owner Redacted  
29/08/2025

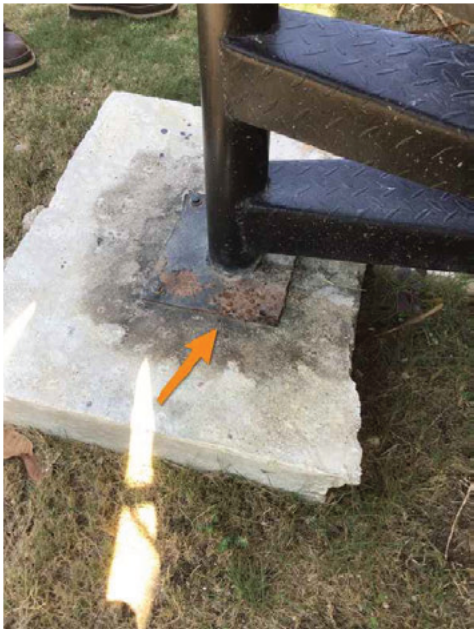
**CORRODING SURFACES**

Rust and corrosion was observed on metal railings, window frames, hinges, doors, etc., This prevented in some instances the proper operation of elements of the property including but to limited to doors and windows.

Recommendation  
Contact a qualified professional.

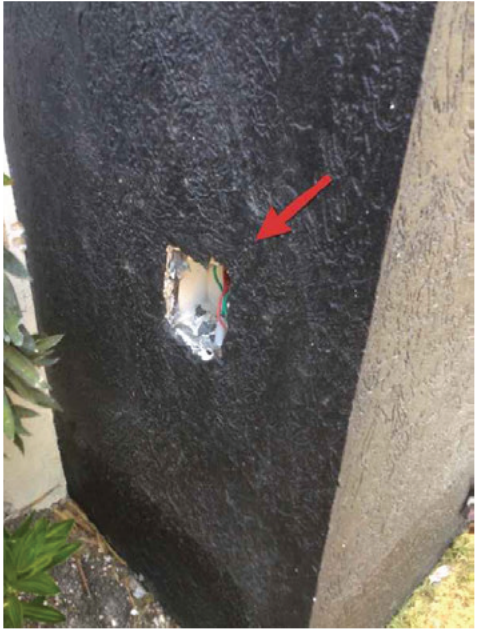
4.1.1 General  
**EXTERIOR ELECTRICAL POINT**  
Exposed wiring. Cover required to prevent water intrusion.  
Recommendation  
Contact a qualified professional.

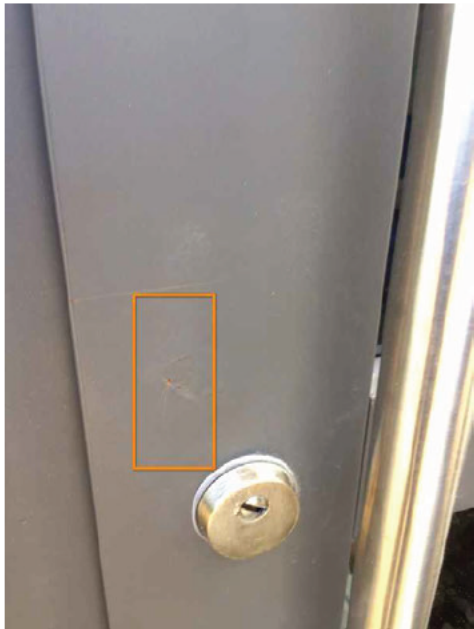
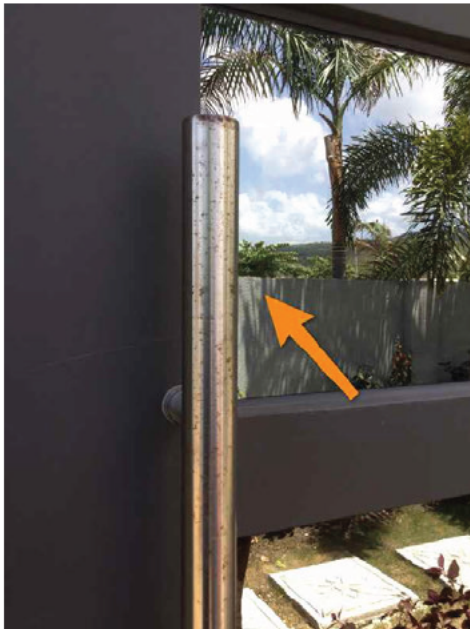
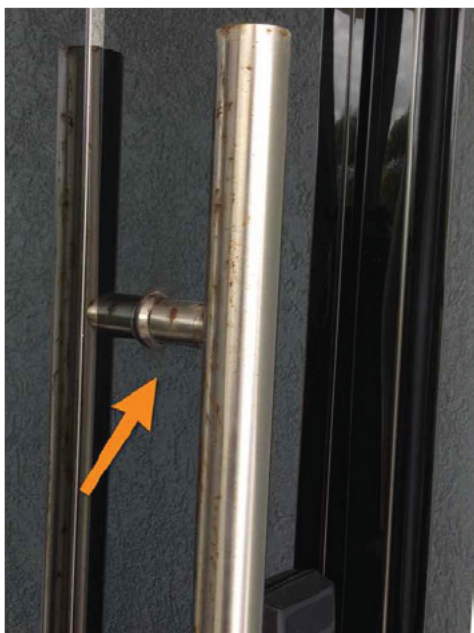
4.4.1 Exterior Doors  
**PAINT/REFINISH NEEDED**  
Door finish is showing evidence of rust caused by exposure to salt. Recommend refinish and/or paint to maximize service life. Best solution is to replace with stainless steel or PVC.

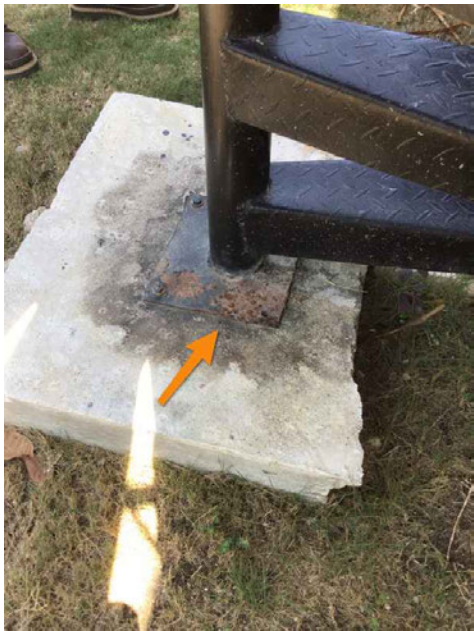
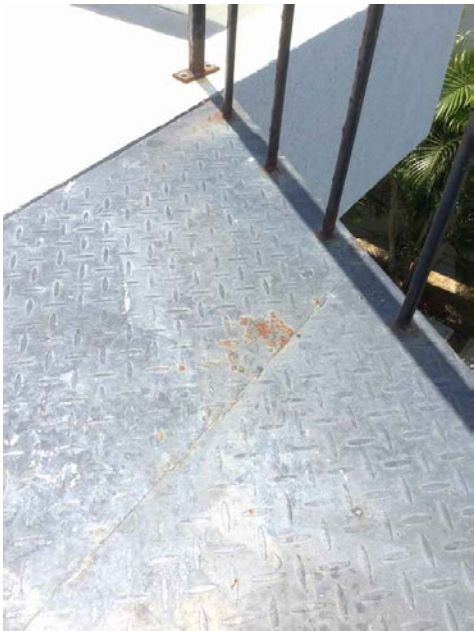
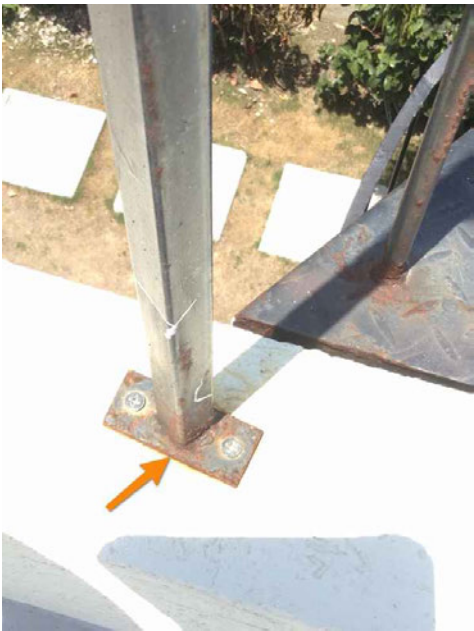
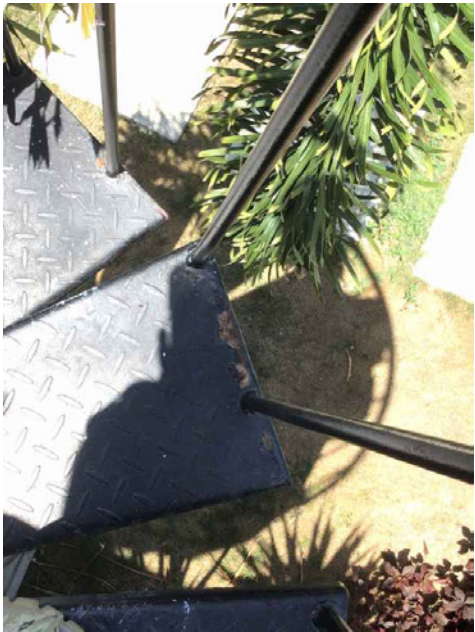
#### 4.8.1 Exterior Stairs

##### **CORROSION**

Recommend replacing high carbon steel with galvanized/aluminum material. Evidence of corrosion observed. Low cost option would include derusting and painting with anti-corrosive paint to slow rust.

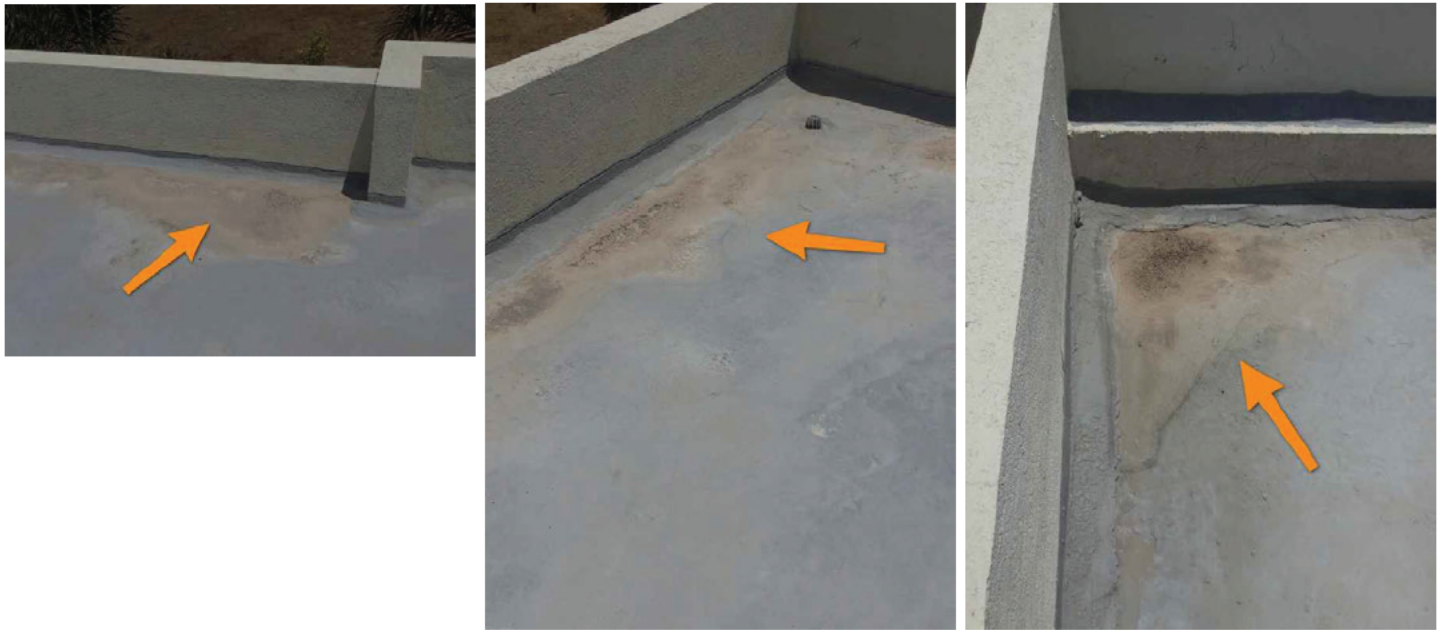
Observed evidence of ponding in one or more areas of roof. Ponding can lead to accelerated erosion and deterioration. Recommend a qualified roofing contractor evaluate and repair.

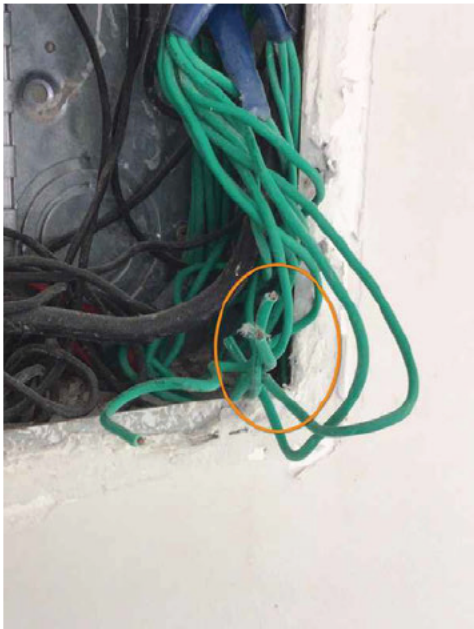
6.3.1 Branch Wiring Circuits, Breakers & Fuses

**LOOSE WIRING**

Loose wiring observed in breaker panel. Recommend qualified electrician identify and connect or remove.

Contact a qualified professional.

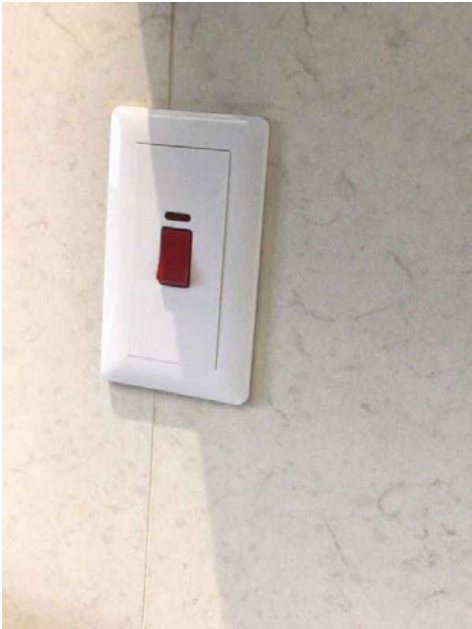
6.6.1 Pilot Switches

Pilot switch in kitchen and laundry room were not operational at the time of the inspection. Recommend replacement by a qualified electrician. A pilot switch is designed to handle 220 volts, which is a higher voltage than standard household circuits and is used for larger appliances and equipment.

Contact a qualified professional.

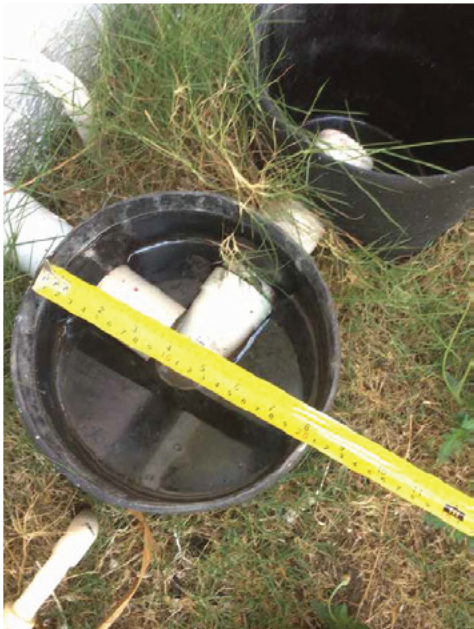
7.2.1 Waste Extraction  
**INADEQUATE TUBE SIZE (WASH WATER)**

Tube is too small for expected volume of wash water. Recommend 12" tube.

Recommendation  
Contact a qualified professional.

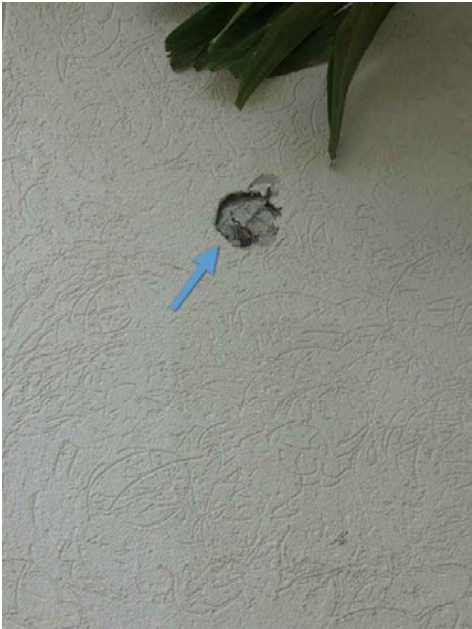
7.3.1 Drain, Waste, & Vent Systems  
**MISSING VENT COVERS**

One or more areas missing vent covers. Recommend installation by qualified professional.

Recommendation  
Contact a qualified carpenter.

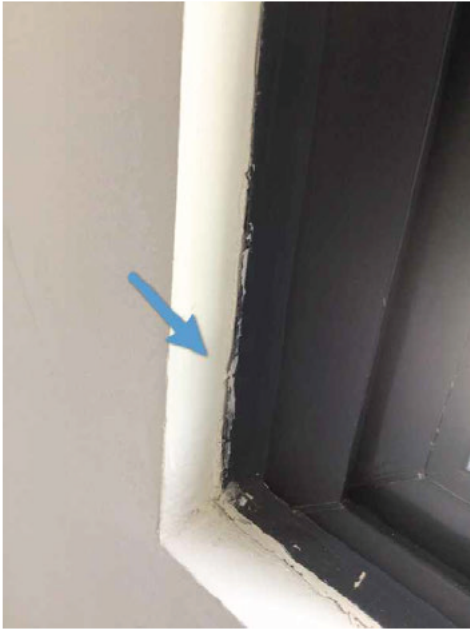
8.3.1 Windows

Observed early failure of seal. Recommend maintenance to prevent lasting damage and eventual moisture intrusion.

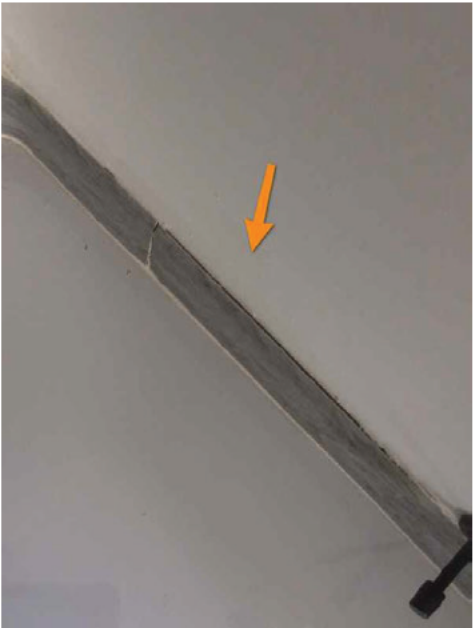
8.8.1 Skirtings

**IMPROPER BONDING**

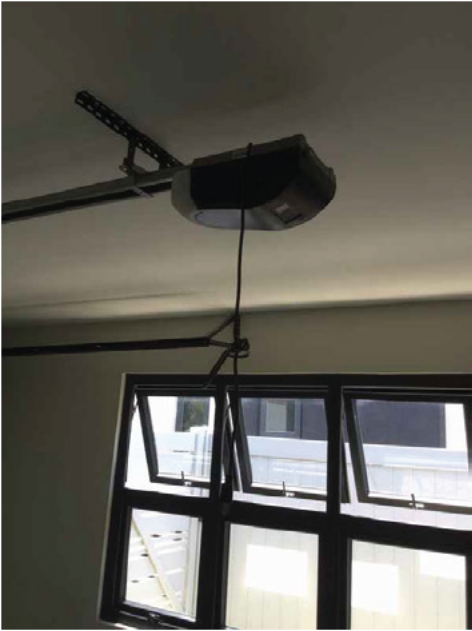
12.4.1 Garage Door  
**NOT OPERATIONAL**  
No power source. Could not test.  
Recommendation  
Contact a qualified professional.
