SUMMARY A2 Highway Belmont , Bluefields, Westmoreland Parish 00000 Client Name Redacted November 24, 2024

This is only a summary of some of the physical deficiencies found during the inspection. Items highlighted in orange and red are most crucial in the opinion of the inspector. It is recommended the full report be reviewed to observe more details regarding other defects and physical deficiencies.

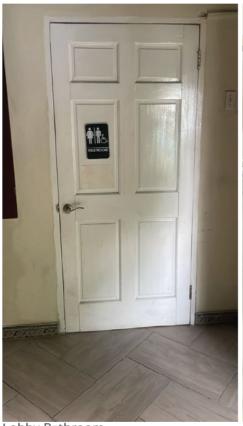
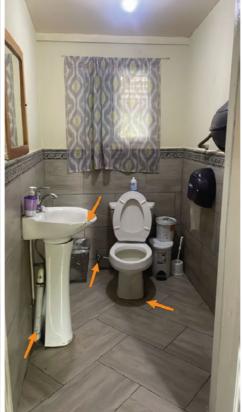
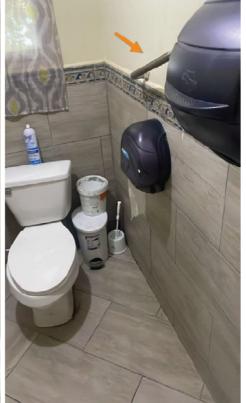
Lobby Bathroom

2.2.1 Bathroom

TOILET & BASIN

The toilet and basin needs to be repaired along with the plumbing of the pressure piping. The grab bar for disabled persons is not installed at the correct height.

Recommendation Contact a qualified professional.

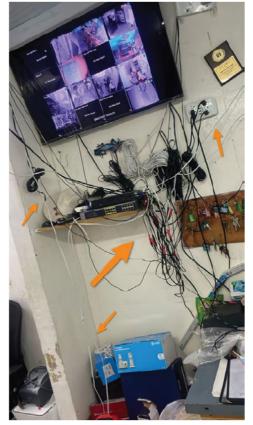
2.3.1 Office

LOOSE WIRES

Loose wires can become a shock or fire hazard and should be corrected.

Recommendation Contact a qualified professional.

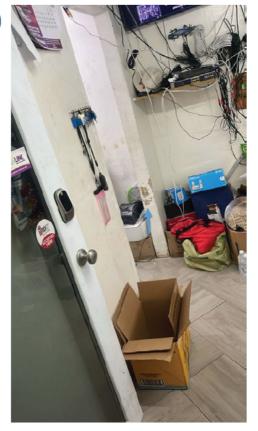
2.3.2 Office

DOOR JAMB

While only a cosmetic defect, the client should note the need for stripping, sanding and repainting of door jambs, walls, etc.,

Recommendation

Contact a qualified professional.

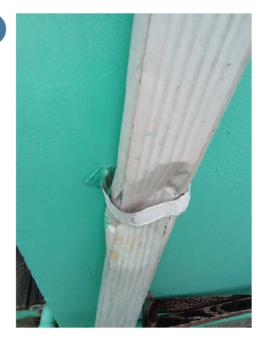
4.2.2 Roof Drainage Systems

DOWNSPOUT DAMAGED

Recommendation Contact a qualified professional.

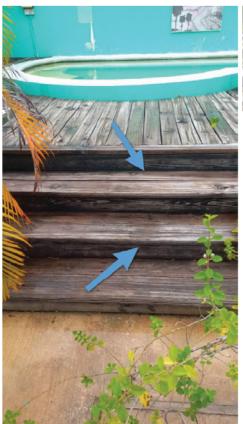
5.1.1 Decks & Balconies

WATER SEALANT REQUIRED

Components were showing signs of weathering and/or minor water damage. Recommend sanding, water sealant / weatherproofing be applied.

Recommendation

Contact a qualified mareino developers jamaica

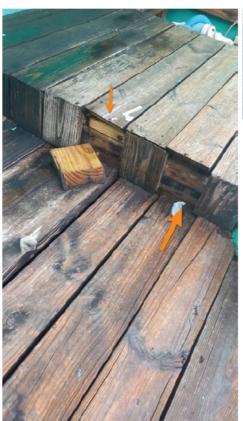
Poolside deck

5.1.2 Decks & Balconies

DAMAGED COMPONENTS

Some of the components on the pool deck require maintenance repairs and weatherproofing. Some component replacement may be needed.

Recommendation Contact a qualified general contractor.

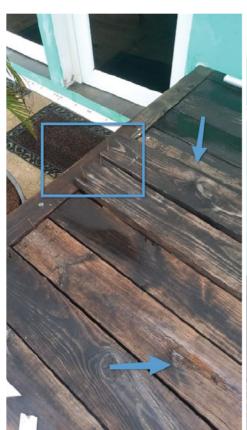
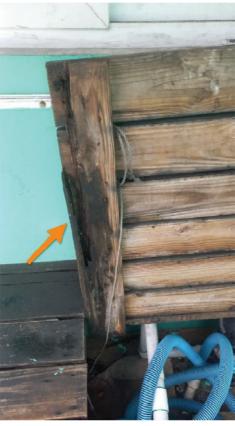
5.1.3 Decks & Balconies

DAMAGED FLOORING

One or more portions of the flooring were observed to have minor damage or deterioration.. Recommend repair..

Recommendation Contact a qualified mareino developers jamaica

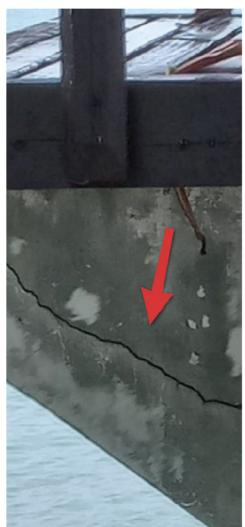
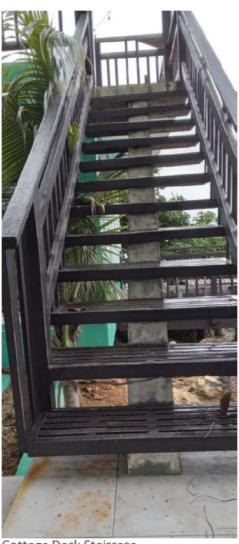
Cottage Deck Staircase

DAMAGED STEPS

The steep leading to the Cottage deck is damaged. Recommend qualified contractor evaluate & repair for continuous use. Replacement maybe necessary.

Recommendation

Contact a qualified mareino developers jamaica

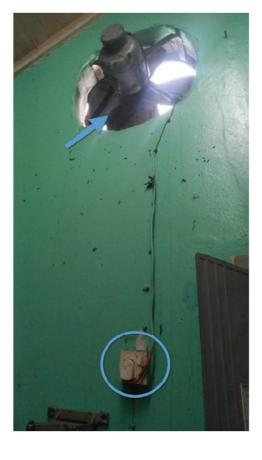
KITCHEN

5.4.1 Exterior Vent (Kitchen)

FAN MAINTENANCE

Recommend fan maintenance.

Recommendation

Contact a qualified professional.

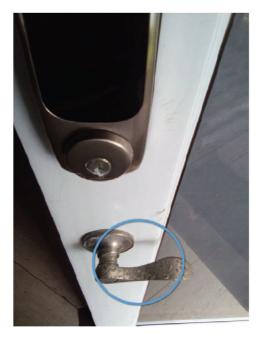
BEDROOMS

6.1.1 Doors & Windows **DOOR HARDWARE**

Door hardware requires maintenance. The hardware should be adjusted, oiled, or replaced. Recommend repair by contractor.

Recommendation

Contact a qualified mareino developers jamaica

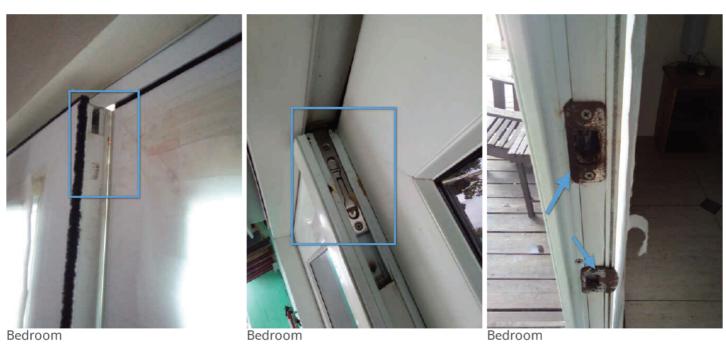
6.1.2 Doors & Windows

DOOR STICKS

Door sticks and is tough to open. Recommend sanding down offending sides or adjustments as needed.

Recommendation

Contact a qualified mareino developers jamaica

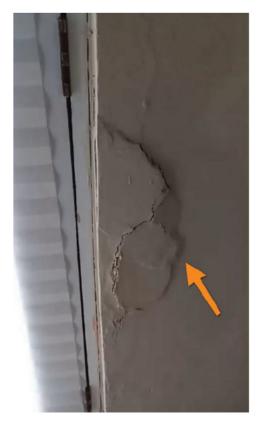
CRACKED MASONRY

Some of the concrete or masonry components were cracked. Recommend a qualified contractor evaluate and repair properly.

Recommendation

Contact a qualified general contractor.

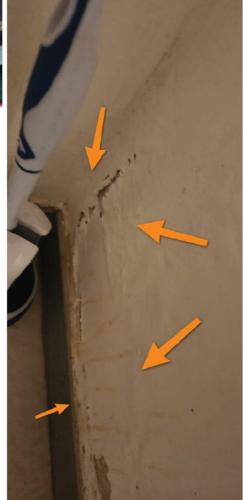
Bedroom Ceiling

Multiple mold growth observed on walls due to moisture intrusion. Cleaning and treatment required.

Recommendation

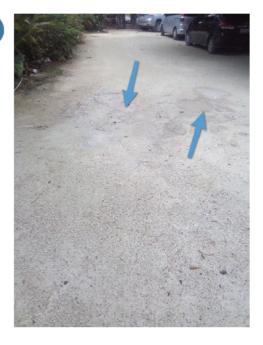
Very little standing water was observed in one or more areas at the front of the property after light rain which could indicate poor drainage and/or grading. Recommend monitor.

Recommendation Contact a qualified grading contractor.

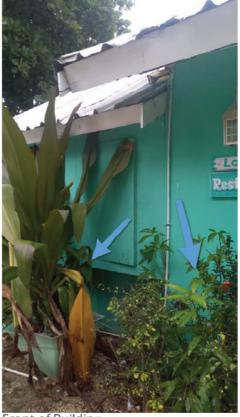
Front of Building

7.1.2 Vegetation, Grading, & General Site **VEGETATION**

Vegetation was noted to be in close proximity of the structure. Recommend trimming or removing to avoid unnecessary damage or moisture intrusion.

Recommendation
Contact a qualified landscaping contractor

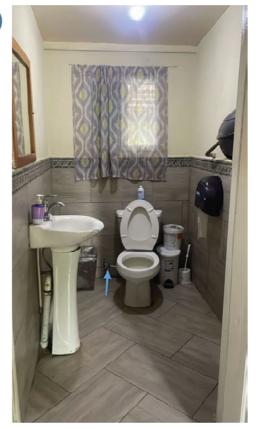
RECOMMEND SHUT-OFF VALVES

Recommendation

Contact a qualified plumbing contractor.

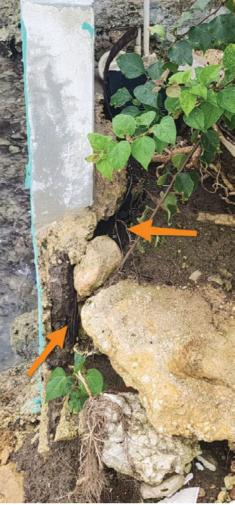
9.2.1 Foundation Walls

The perimeter wall in the bar area needs to be extended and repaired. Signs of corrosion on the rebars and soil erosion present. Early correction can prevent more extensive and expensive repairs.

Recommendation

Contact a qualified professional.

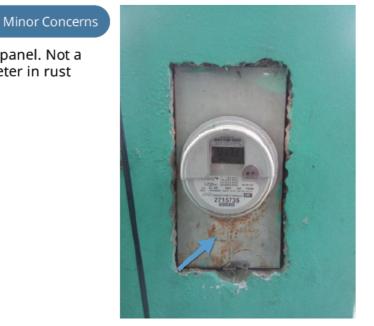
10.1.1 Service Entrance Conductors

METER RUSTED

Rust was observed on the exterior cover of the meter panel. Not a significant issue however cleaning and coating the meter in rust proof paint can extend life of panel.

Recommendation Contact a qualified electrical contractor.

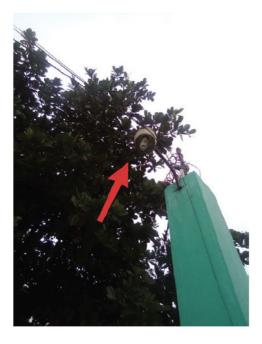
10.1.2 Service Entrance Conductors

TREE BRANCHES

Tree branches should be cut back from utility line.

Recommendation Contact your local utility company

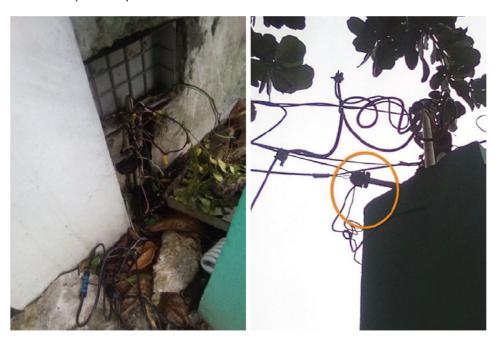
10.1.3 Service Entrance Conductors

ABANDONED WIRING

Recommend removal by licensed electrician

Recommendation

Contact a qualified professional.

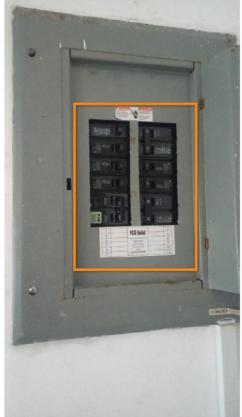
No labels cottage

10.2.1 Main & Subpanels **MISSING LABELS**

At the time of inspection, the main panel, sub main in the Cottage and Bar had no labels to identify and differentiate breakers. Recommend a qualified electrician identify and map out locations to verify.

Recommendation

Contact a qualified pink electric

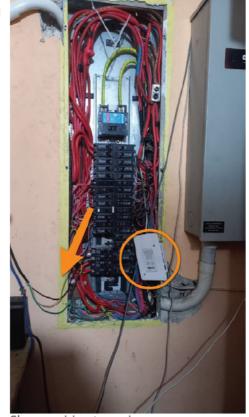
IMPROPER WIRING METHODS

Some sloppy or improper wiring methods were noted running to and from the panel. Wire nuts or crowded wiring is not recommended. This can be a fire hazard.

Sloppy wiring to main

Recommendation

Contact a qualified electrical contractor.

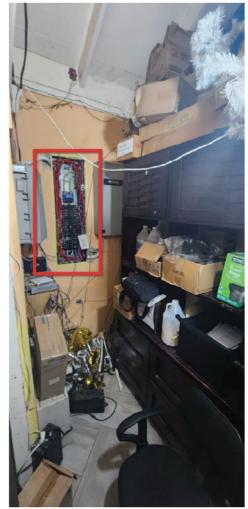
10.2.3 Main & Subpanels PANEL COVER MISSING

The panel cover was missing on main panel in lobby area. Recommend installation soon.

No cover

Recommendation

Contact a qualified electrical contractor.

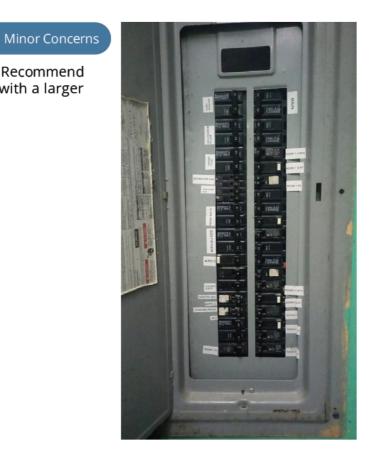
10.2.4 Main & Subpanels

The panel had no more space for additional circuits. Recommend exploring options for a sub-panel or upgrade service with a larger panel.

Recommendation Contact a qualified pink electric

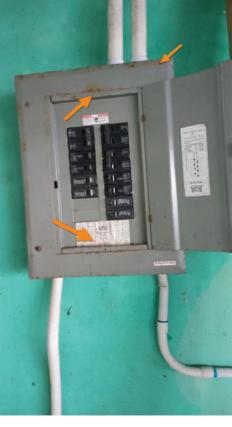
IMPROPER LOCATION

Recommendation

Contact a qualified professional.

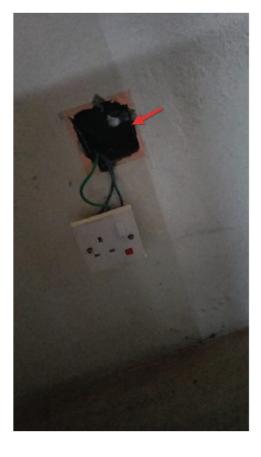
10.3.1 Branch Wiring Circuits **DAMAGED COMPONENTS**

Any damaged or corroded electrical components should be repaired or replaced by a licensed electrician.

Recommendation
Contact a qualified pink electric

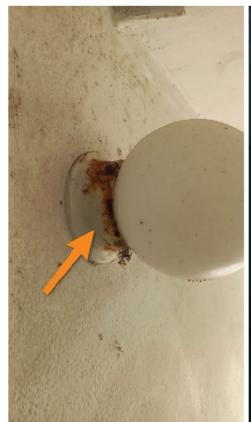
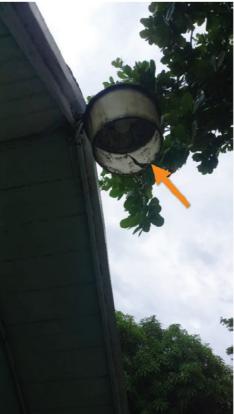
Lights in rooms/exterior

Exterior Light

Recommendation

Contact a qualified pink electric

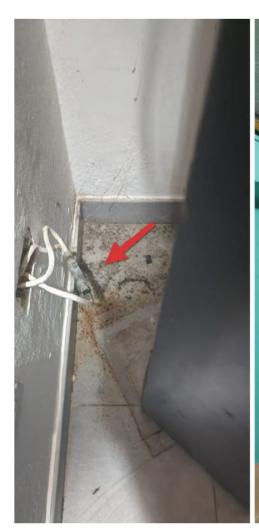
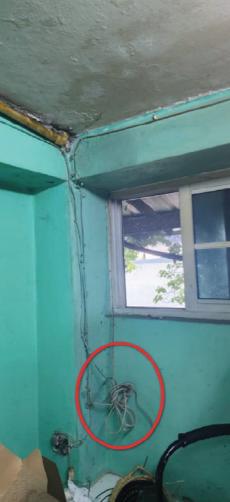
10.4.2 Lighting, Fans, Switches, & Receptacles **LOOSE COMPONENTS**

All loose components, especially wires should be repaired and secured prior to use.

Recommendation Contact a qualified pink electric

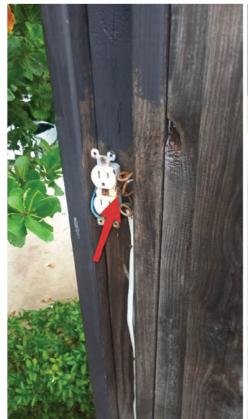
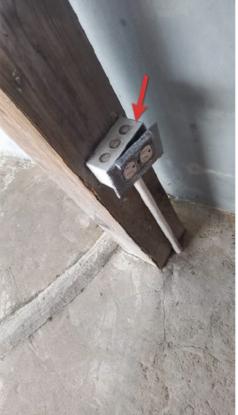
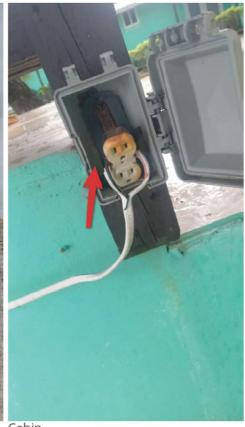
Bar Outlet Cabin

10.4.3 Lighting, Fans, Switches, & Receptacles **DAMAGED COMPONENTS**

All damaged or corroded electrical components should be repaired or replaced by a licensed electrician.

Recommendation Contact a qualified pink electric

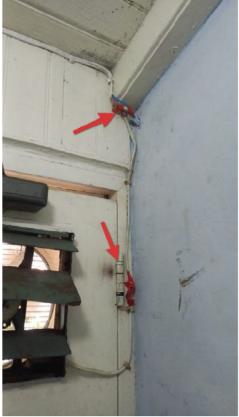
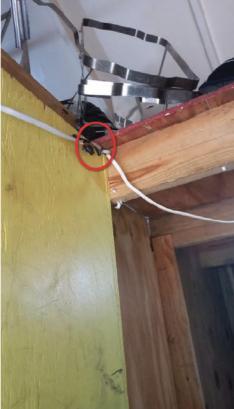
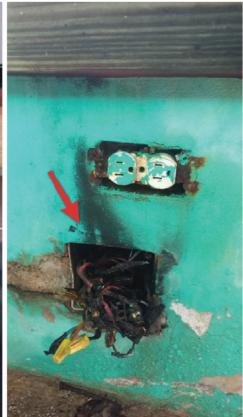
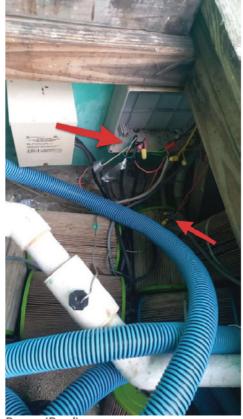
10.4.4 Lighting, Fans, Switches, & Receptacles **IMPROPER WIRING**

Multiple loose and exposed wiring was observed. This should be modified for improved safety. Securing wires and adding junction boxes as needed is recommended. Recommend a licensed electrician evaluate and repair properly immediately. This is a Fire hazard.

Kitchen Exhaust Fan

Storage Room

Below Pool Deck

Pump (Pool)

Contact a qualified electrical contractor.

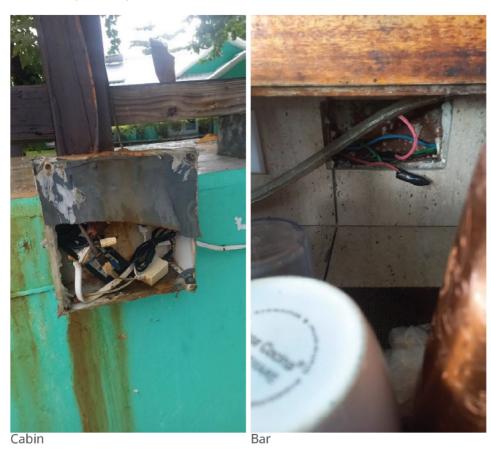
COVER PLATE REPAIR

One or more junction boxes, receptacles, or switches were missing a cover plate or cover plate is damaged. This causes short and shock risk. Any junction boxes should have cover plates as well. Recommend installation of plates.

Recommendation Contact a qualified pink electric

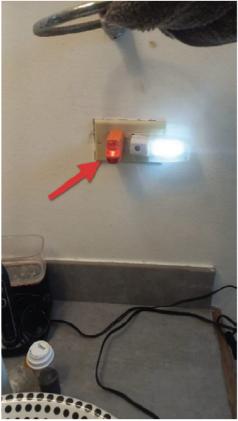
Cottage

10.4.7 Lighting, Fans, Switches, & Receptacles

One or more receptacles had been wired with an open ground. This can create a shock hazard. Recommend licensed electrician evaluate & repair.

Recommendation

Contact a qualified electrical contractor.

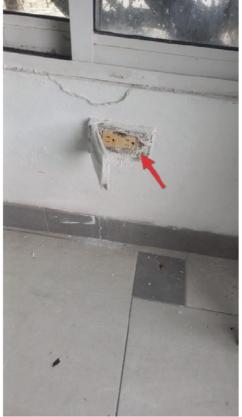
Cottage

10.4.8 Lighting, Fans, Switches, & Receptacles

One or more outlets were inoperable. Recommend a licensed electrician evaluate further and replace.

Recommendation

Contact a qualified electrical contractor.

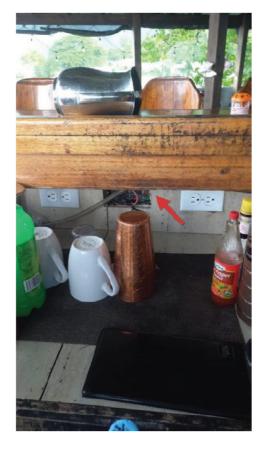
10.4.9 Lighting, Fans, Switches, & Receptacles

The outlet location was improper and may inadvertently cause a hazard. Ceiling mounted or side cabinet outlets should be relocated. Recommend relocation of the circuit and outlet.

Recommendation

Contact a qualified electrical contractor.

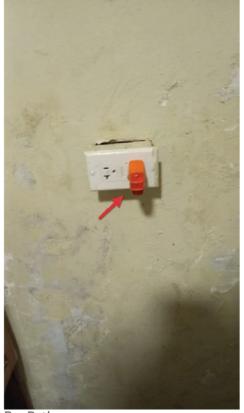
Bar Bathroom

10.4.10 Lighting, Fans, Switches, & Receptacles

The GFCI was not tripping properly. Recommend repair or replacement of all GFCI plugs on the property.

Recommendation

Contact a qualified pink electric

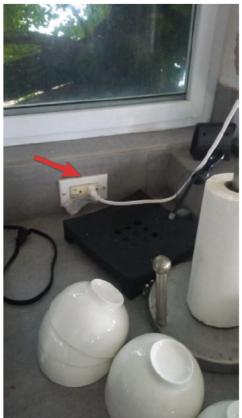
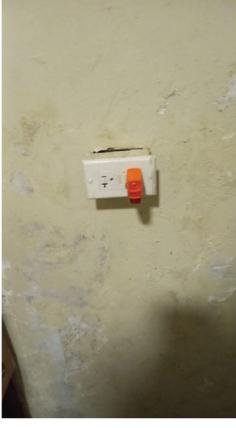
Bar Sink

10.4.11 Lighting, Fans, Switches, & Receptacles

No GFCI protection was present in some locations. GFCI's are recommended in kitchens, baths, garages, and exterior applications. Recommend licensed electrician upgrade by installing ground fault receptacles in all necessary locations.

Recommendation Contact a qualified electrical contractor.

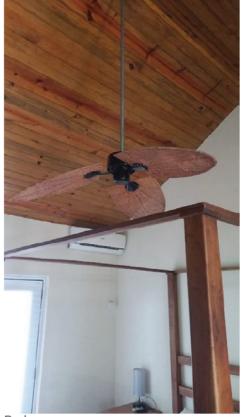
Bedrooms

10.4.12 Lighting, Fans, Switches, & Receptacles

FAN REPAIR

The fans were either noisy or wobbly. Recommend repair or replacement prior to use in all bedrooms

Recommendation

Contact a qualified electrical contractor.

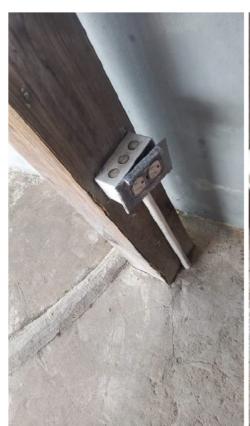
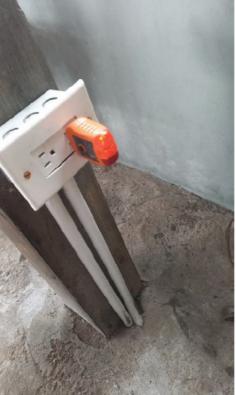
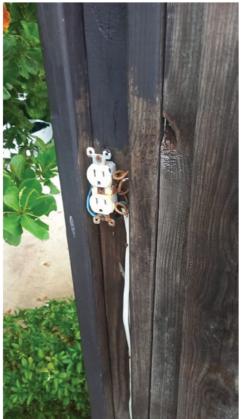
Multiple outlets in the Bar area needs waterproof covers to prevent moisture intrusion which can cause fire or short circuit.

Bar Balcony

Cabin Deck

Recommendation

Contact a qualified professional.

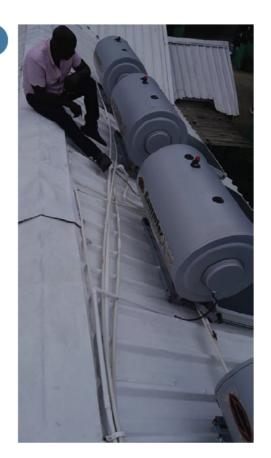
Water heaters should be flushed annually to prevent sediment buildup and maintain efficiency. Burner chambers should also be serviced and cleaned. Recommend a qualified plumber service and flush. There was no evidence of yearly maintenance. Immediate cleaning recommended.

Recommendation

Contact a qualified plumbing contractor.

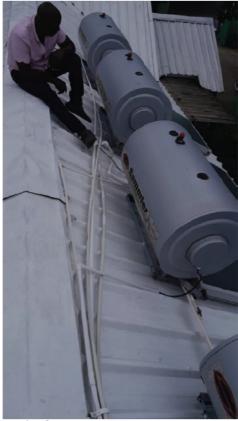
Bank of Four

11.1.3 Water Heater(s)

IMPROPER INSTALLATION

All Water heaters were improperly installed. Recommend qualified plumber evaluate & repair. Copper pipes should be used for header lines with lines running to each unit from that single header line to supply each heater instead of PVC.

Recommendation

Contact a qualified plumbing contractor.

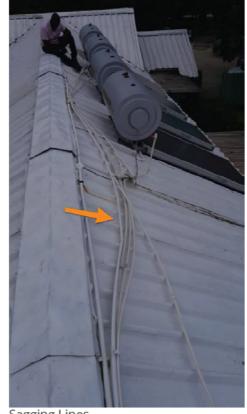
Sagging Lines

11.1.4 Water Heater(s)

Recommendation Contact a qualified professional.

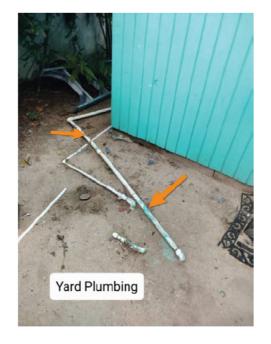
11.2.3 Water Supply & Distribution Systems **IMPROPER INSTALLATION**

Distribution pipes or components were installed in a sub-standard way. The pressure plumbing bath is hot and cold. I recommend pipes and components be replumbed and repaired to meet current construction standards.

Recommendation

Contact a qualified plumbing contractor.

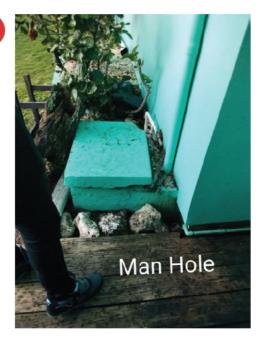
Side view gully basin is inaccessible. recommend correcting.

Recommendation Contact a qualified professional.

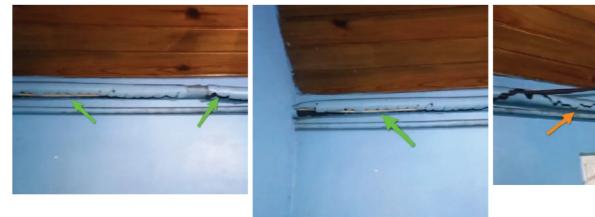
INSULATION DAMAGED

Missing or damaged insulation on refrigerant line can cause energy loss and condensation.

Recommendation Contact a qualified pink electric

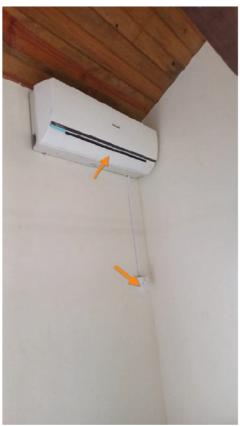
Room 6 AC

12.2.2 Cooling Equipment

The cooling unit (Fan and AC) was inoperable at time of inspection in room #6. Fan inoperable in bedroom 5. Recommend a qualified HVAC professional evaluate & ensure functionality.

Recommendation
Contact a qualified HVAC professional.

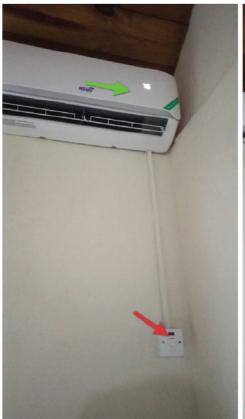
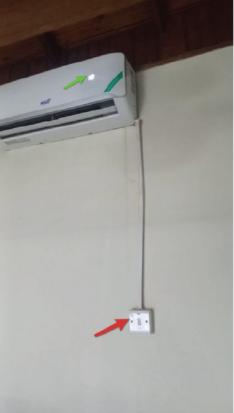
IMPROPER INSTALLATION

Apartment 9

Apartment 4

Recommendation

Contact a qualified pink electric

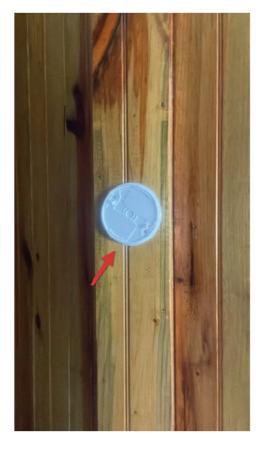
14.3.2 Fire Safety

MISSING DETECTORS

Some missing detectors were noted. Smoke detectors should be installed in every living space and a minimum of one CO detector per floor should be installed.

Recommendation

Contact a qualified electrical contractor.
